EST3 Version 3.72 Release Notes

Content

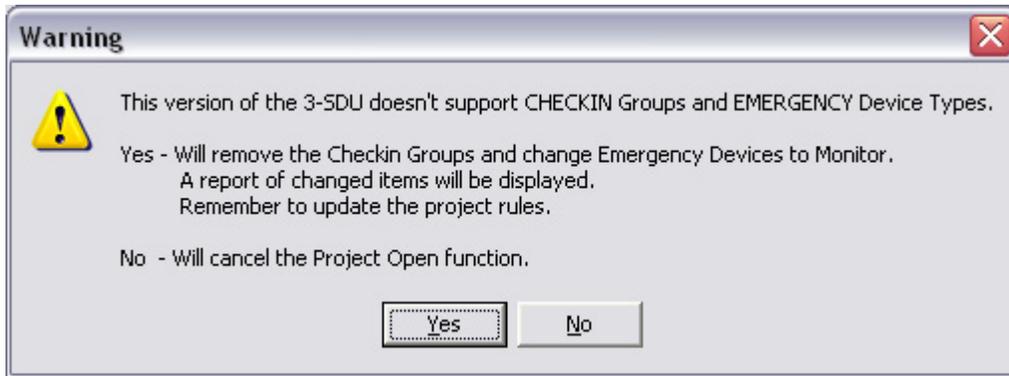
When you attempt to open a project containing CHECK-IN groups and EMERGENCY device types a warning message appears.

Figure 1: Check-In group warning message

Clicking Yes removes these objects from your project. You will have to change any rules that use these objects. This affects only Check-in groups and Emergency device types.

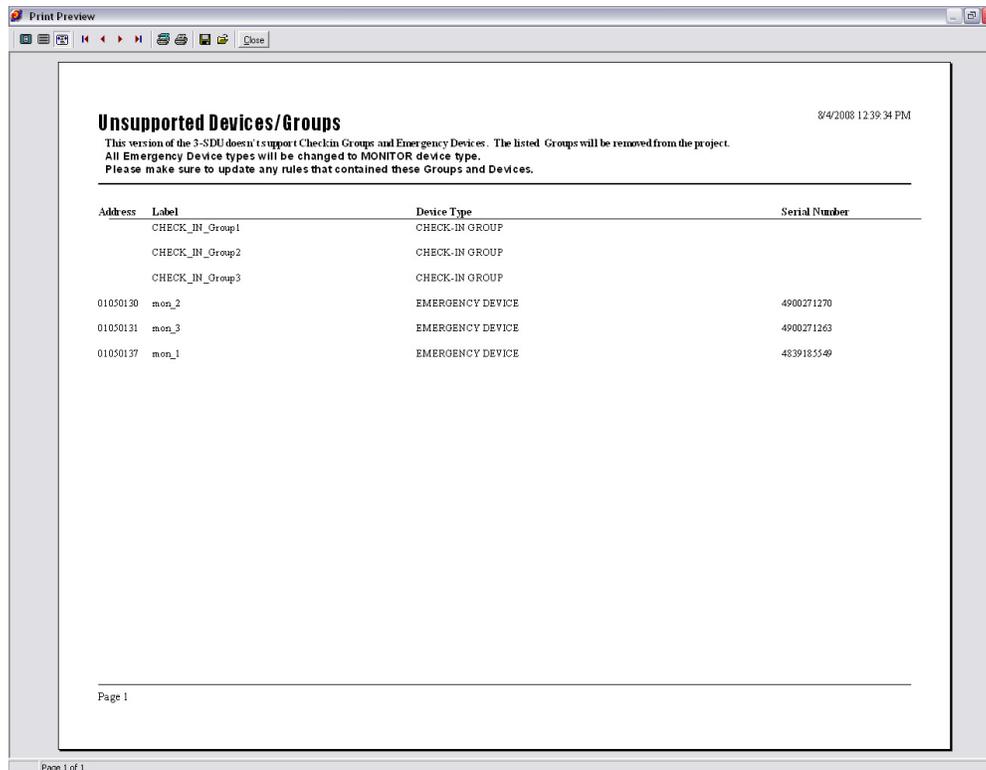
A report is displayed showing all the CHECK-IN groups removed. All EMERGENCY device types will be changed to MONITOR device types. Use this information to modify your rules and devices.

Figure 2: Unsupported Devices/Groups sample report

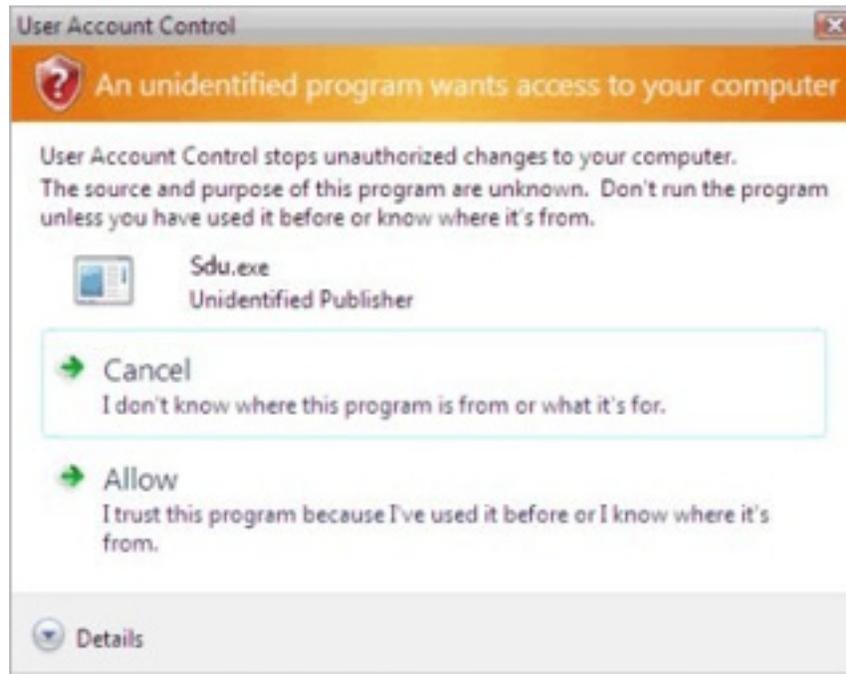
Some features in the 3-SDU require the program to be run with higher privileges in Vista's new Execution Level scheme. However, running at the higher privilege level currently results in the following screen being displayed.

Figure 3: User Account Control message box

This is displayed because the 3-SDU is not currently certified with electronic signature verification software. This issue will be remedied in the next release. In the meantime, select the Allow option to run your 3-SDU with full functionality.
